SUMMARY TRIP REPORT AND PHOTOGRAPHS

**Visual Site Inspection
Photograph Log
January 6, 1992**

**Mobil Chemical Company
Temple, Texas**

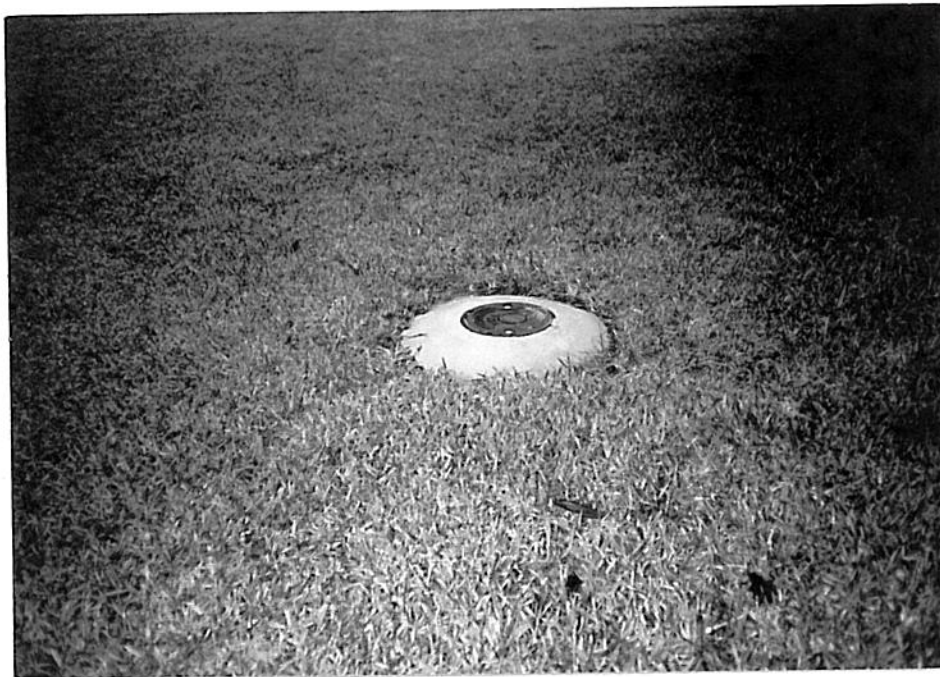
- 1 01-06-92, 9:10 a.m. View to the east. Hazardous Waste Underground Storage Tank (SWMU #1). Photo taken by Michael Lanz.

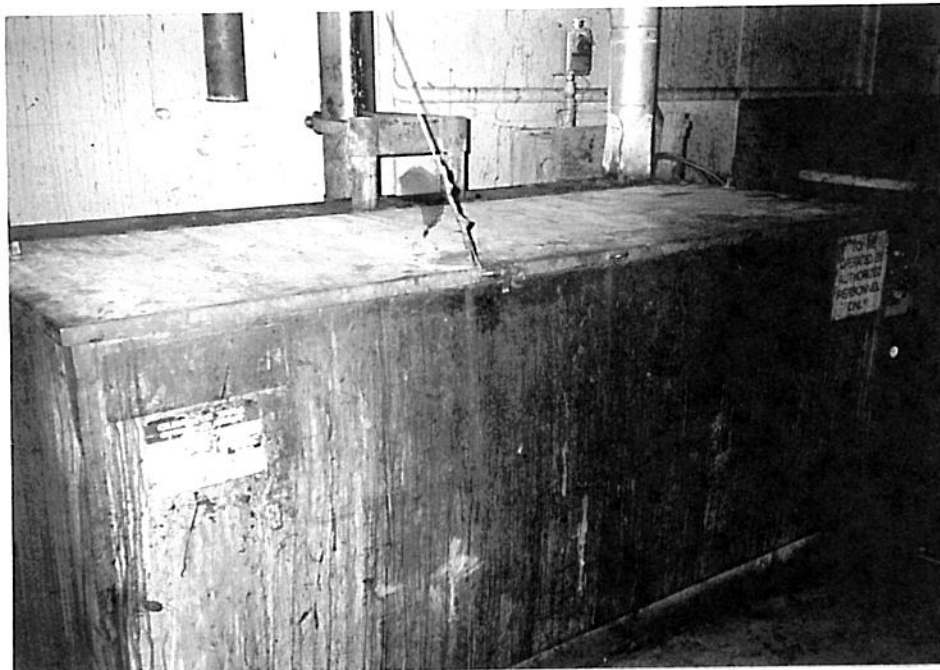
- 2 01-06-92, 9:20 a.m. General Products Graphic Arts Department. Tray Cleaning Station portion of SWMU #2. Staining on outside of unit is water-based ink. Photo taken by Michael Lanz.

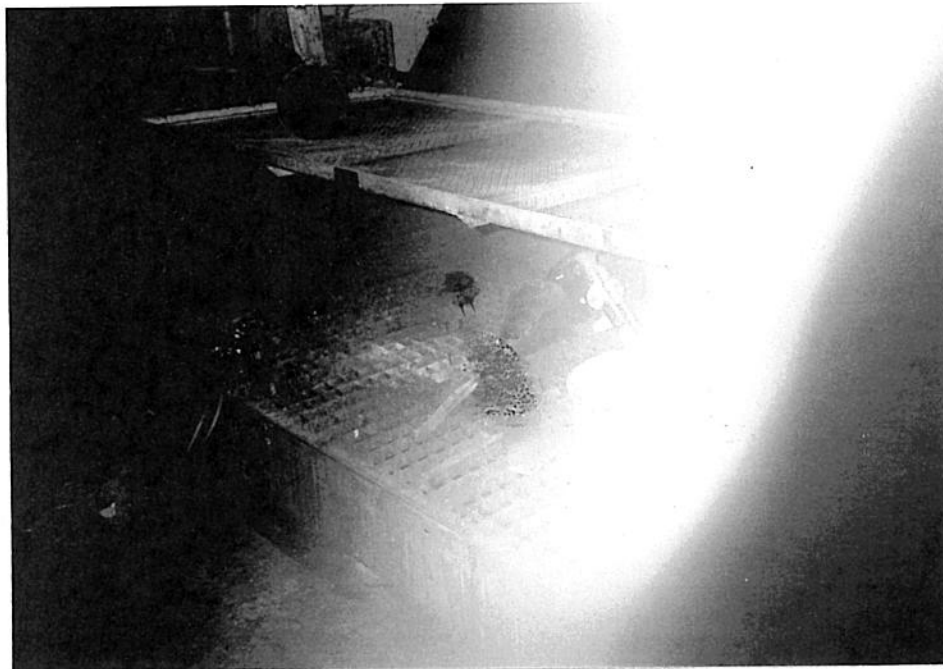
- 3 01-06-92, 9:25 a.m. General Products Graphic Arts Department. Tray Rinsing Station - portion of SWMU #2. Staining on outside of unit is water-based ink. Photo taken by Michael Lanz.

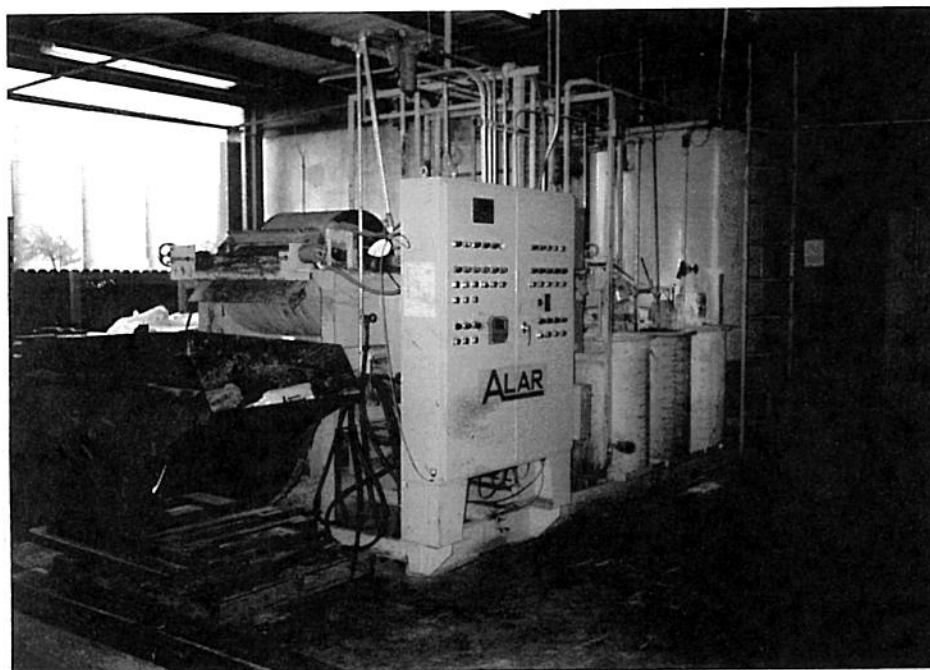
- 4 01-06-92, 9:30 a.m. View to the east. Outside General Products Graphic Arts Department. Overview of ALAR System (SWMU #3). Note (from background to foreground) the 1,000-Gallon Mixing Tank, the three Holding Tanks, the Rotating Steel Drum, and the Solid Ink Waste Container. Photo taken by Michael Lanz.

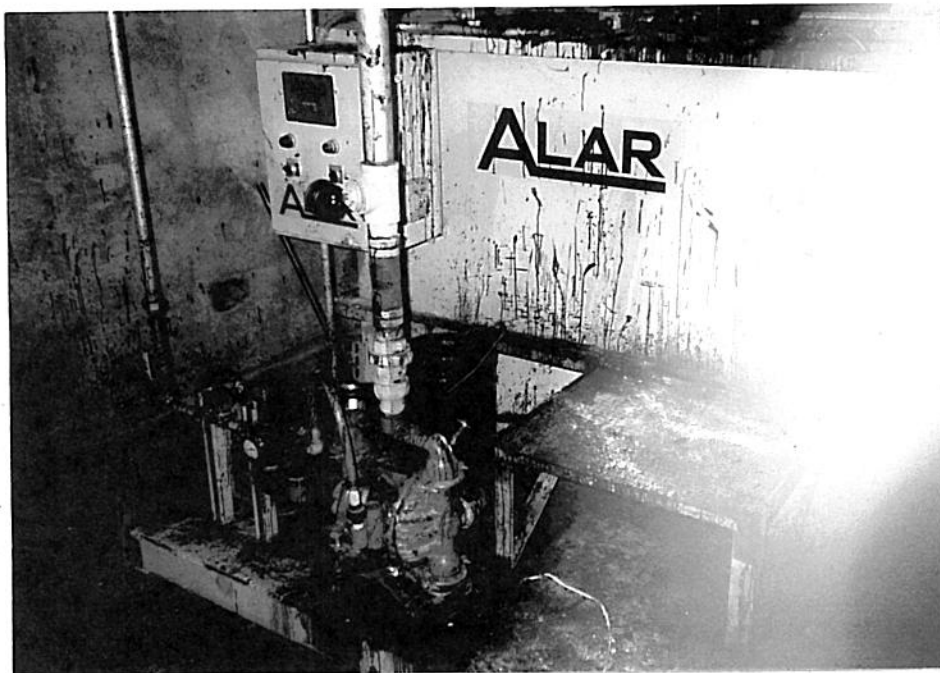
- 5 01-06-92, 9:32 a.m. View to the east. Outside General Products Graphic Arts Department. 500-Gallon Holding Tank with Water Pump of the ALAR System (SWMU #3). The staining on the outside of the container is water-based ink. Photo taken by Michael Lanz.

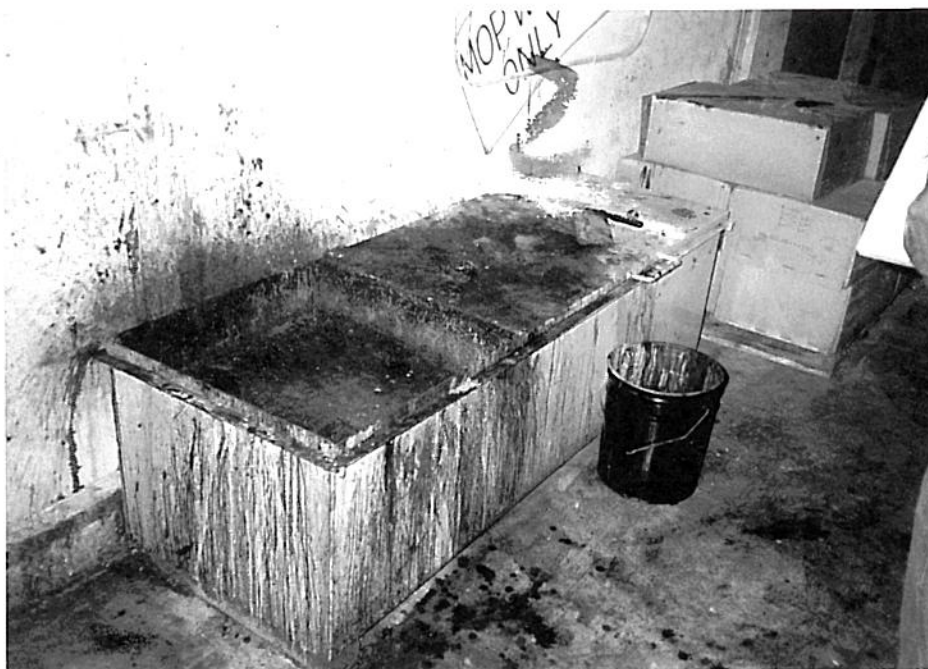
- 6 01-06-92, 9:40 a.m. View to the south. Outside General Products Graphic Arts Department. Mop Water Tank (SWMU #4). The staining on the outside of the unit and on the wall behind the unit is water-based ink. Photo taken by Michael Lanz.

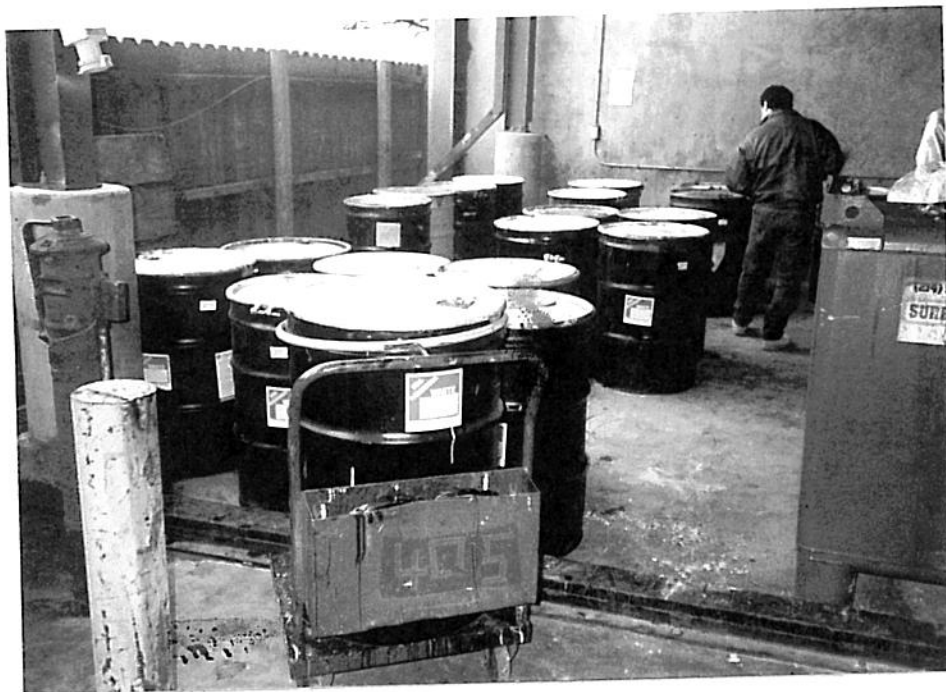
- 7 01-06-92, 9:35 a.m. View to the east. Outside General Products Graphic Arts Department. Nonhazardous Drum Storage Area (SWMU #5). Photo taken by Michael Lanz.

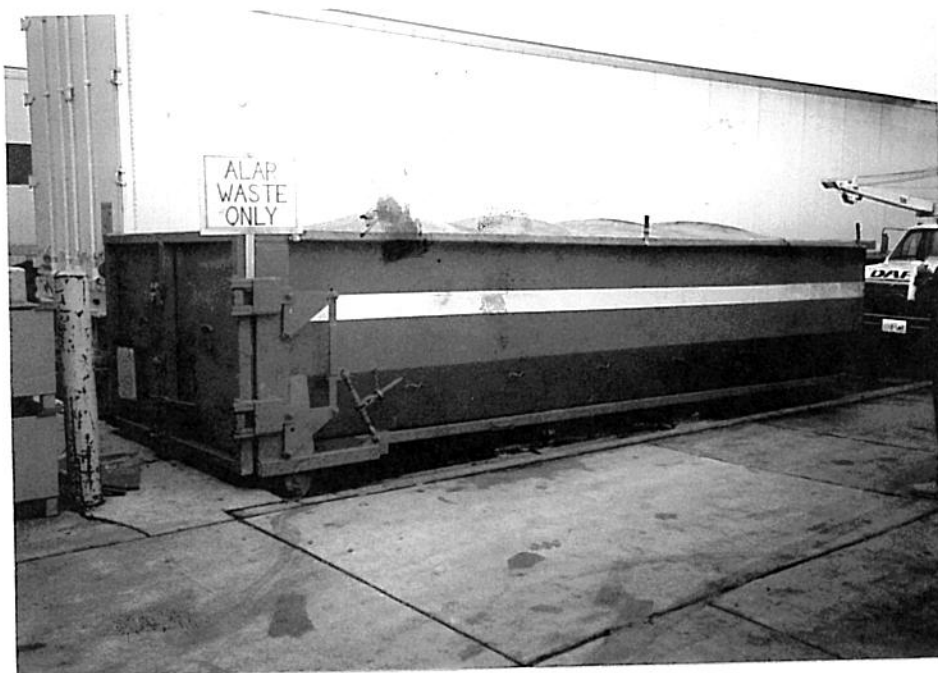
- 8 01-06-92, 9:40 a.m. View to the west. Between the General Products and Foam plants. 30-Cubic Yard Roll-Off Container (SWMU #6). Photo taken by Michael Lanz.

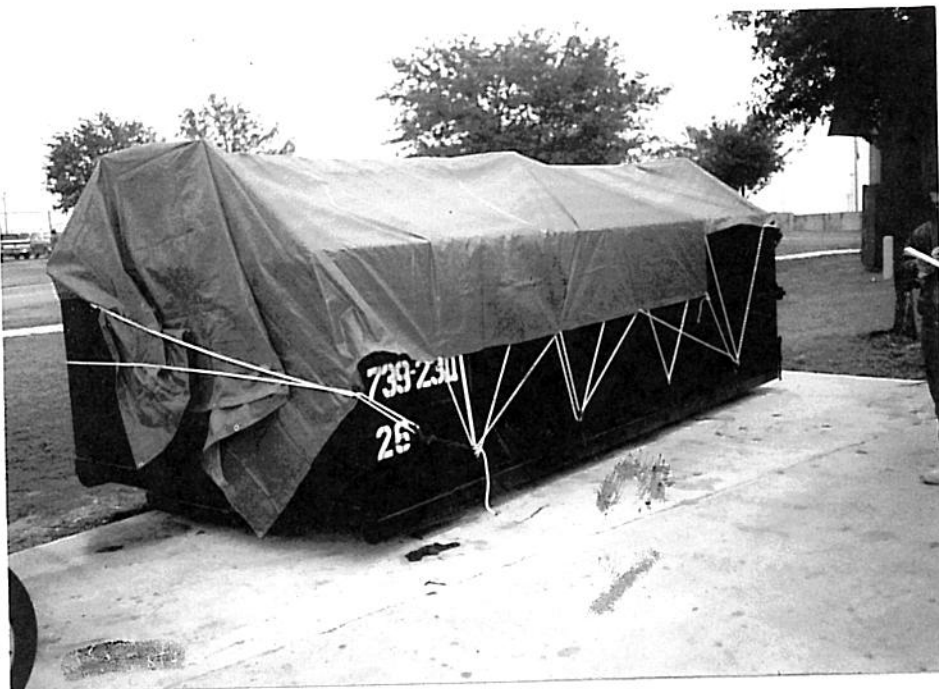
- 9 01-06-92, 9:45 a.m. View facing southeast. Between the General Products and Foam plants. 20-Cubic Yard Scrap Metal Roll-Off Container (SWMU #7). Photo taken by Michael Lanz.

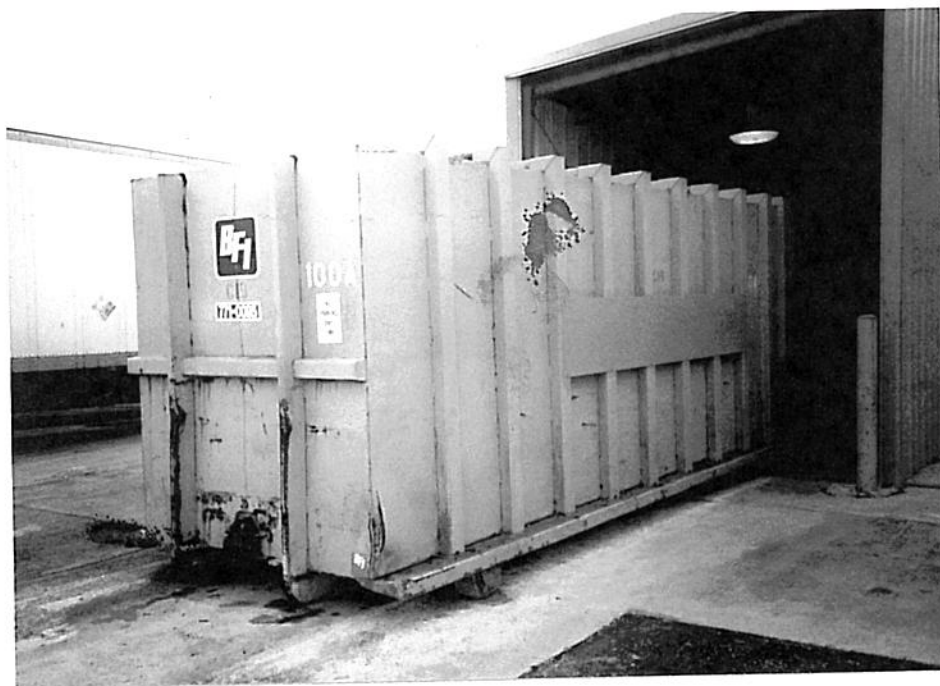
- 10 01-06-92, 9:47 a.m. View facing north. Between stretch film manufacturing and scrap film storage. 40-Cubic Yard Roll-Off Container of Trash Compactor/40-Cubic Yard Roll-Off Container (SWMU #8). Photo taken by Michael Lanz.

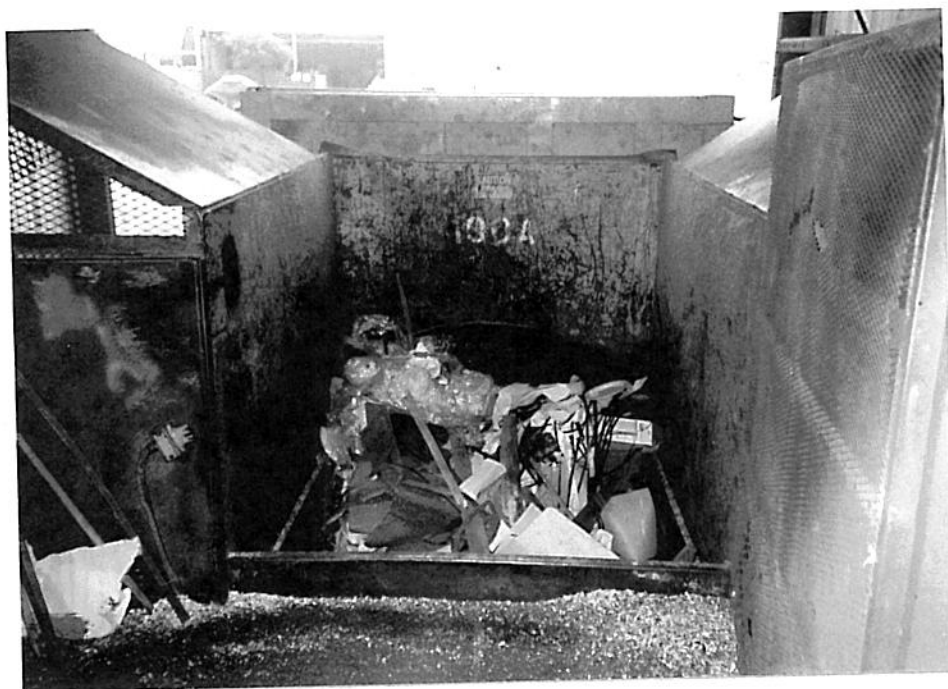
- 11 01-06-92, 9:48 a.m. View facing south. Stretch film manufacturing department. Trash Compactor of Trash Compactor/40-Cubic Yard Roll-Off Container (SWMU #8). Photo taken by Michael Lanz.

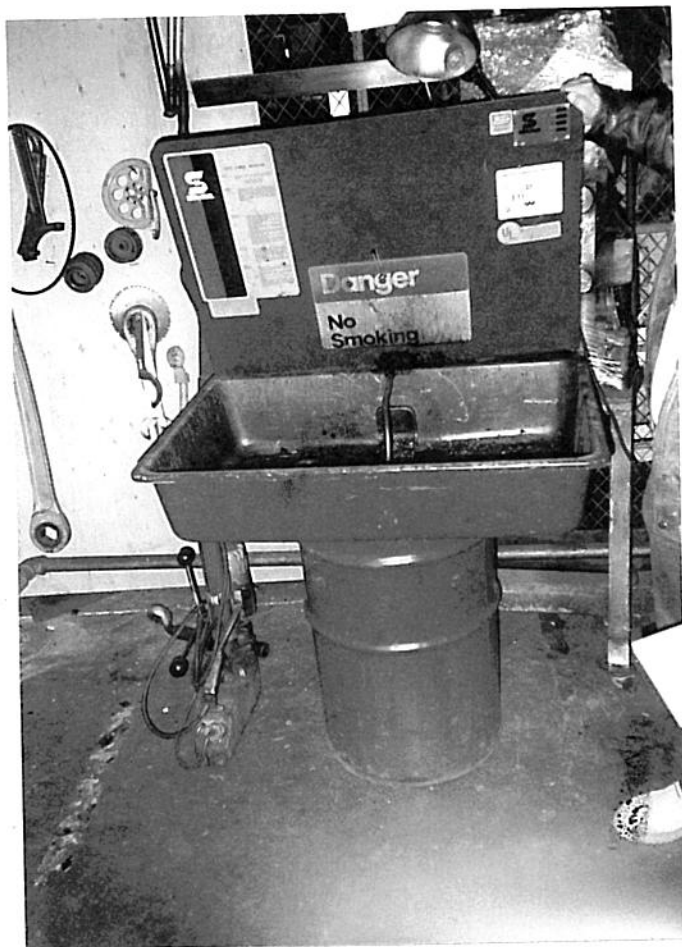
- 12 01-06-92, 10:00 a.m. One of several views of Safety Kleen Stations in the General Products and Foam plants (SWMUs #9 and 16). 30-gallon capacity. Photo taken by Michael Lanz.

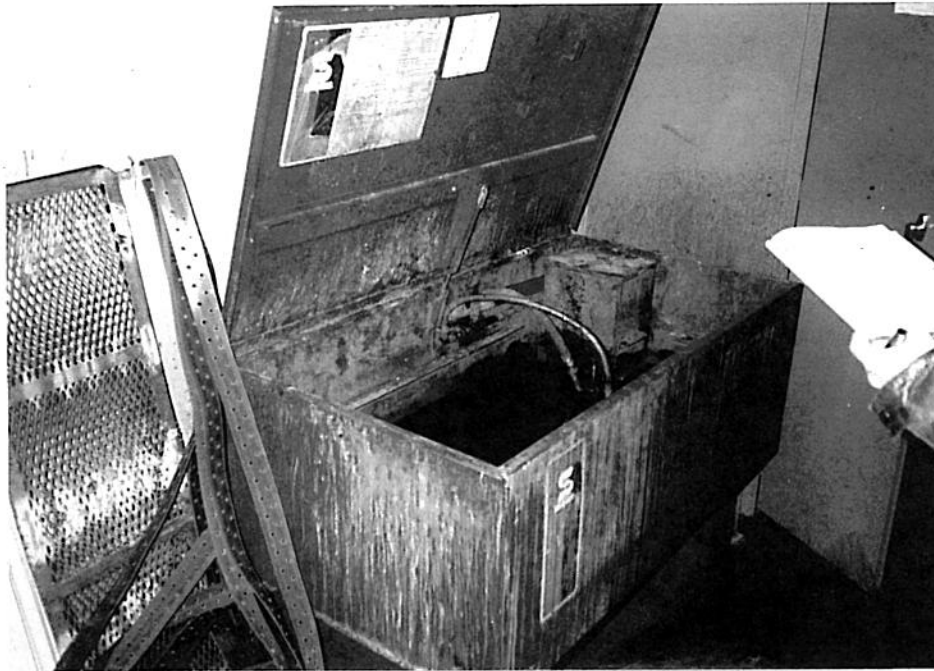
- 13 01-06-92, 10:02 a.m. One of several views of Safety Kleen Stations in the General Products and Foam plants (SWMUs #9 and 16). 60-gallon capacity. Photo taken by Michael Lanz.

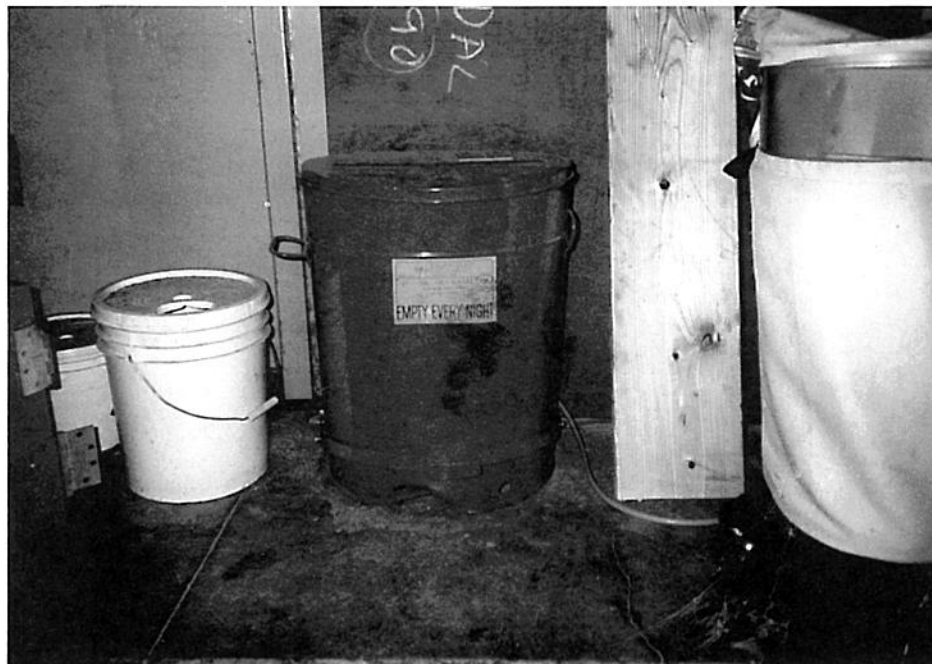
- 14 01-06-92, 10:10 a.m. One of several views of Satellite Accumulation Areas in the General Products and Foam plants. (SWMUs #10 and 17) for oily rags: red container. Photo taken by Michael Lanz.

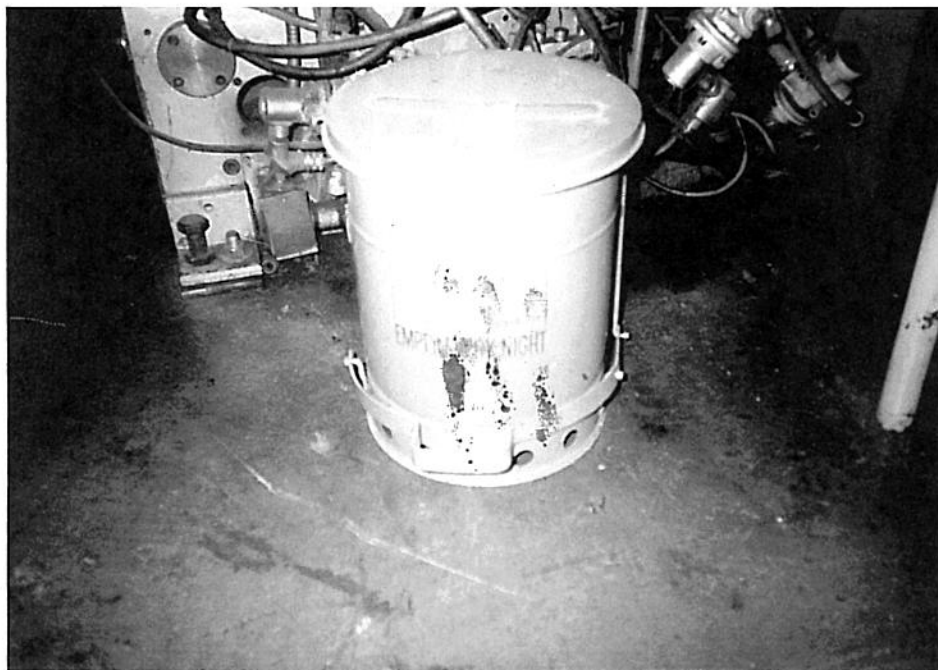
- 15 01-06-92, 10:12 a.m. One of several views of Satellite Accumulation Areas (SWMUs #10 and 17) in the General Products and Foam plants for oily rags: yellow container. Photo taken by Michael Lanz.

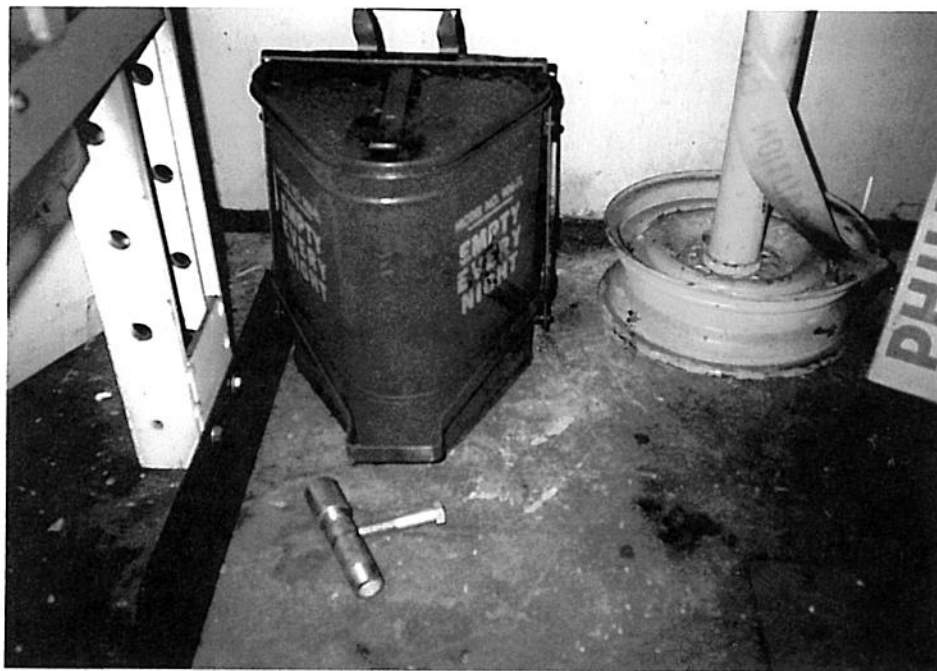
- 16 01-06-92, 10:13 a.m. One of several views of Satellite Accumulation Areas (SWMUs #10 and 17) for aerosol cans: triangular red containers. Photo taken by Michael Lanz.

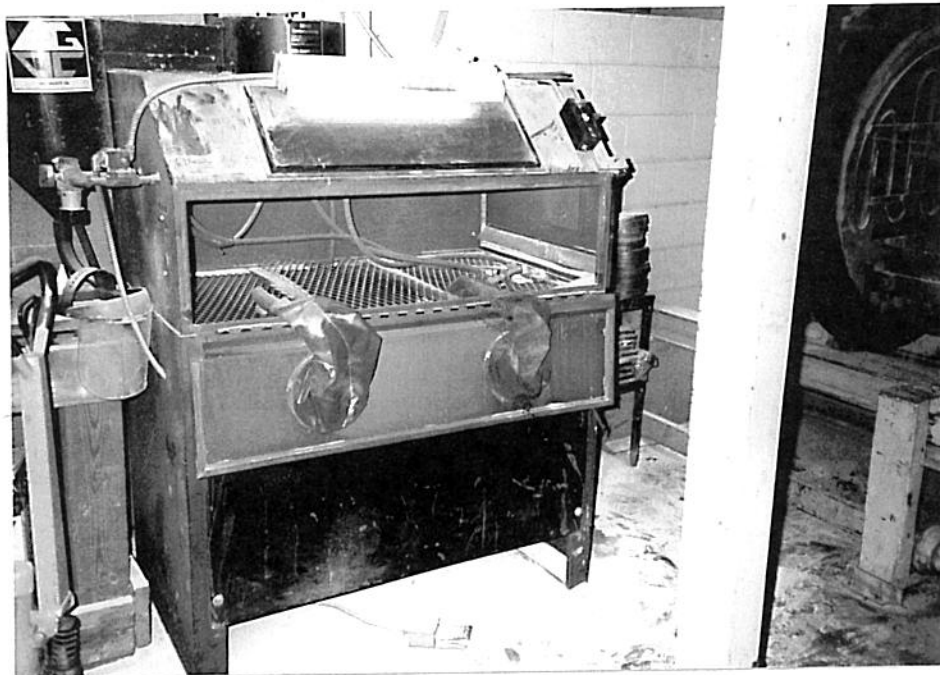
17 01-06-92, 10:00 a.m. General Products Maintenance Department. Sandblasting Unit (SWMU #11). The white powder on the floor is sand from the sandblasting process. Photo taken by Michael Lanz.

- Sandblasting Unit (SWMU No. 11) (Conditional)
- Construction Debris Accumulation Area (SWMU No. 27)

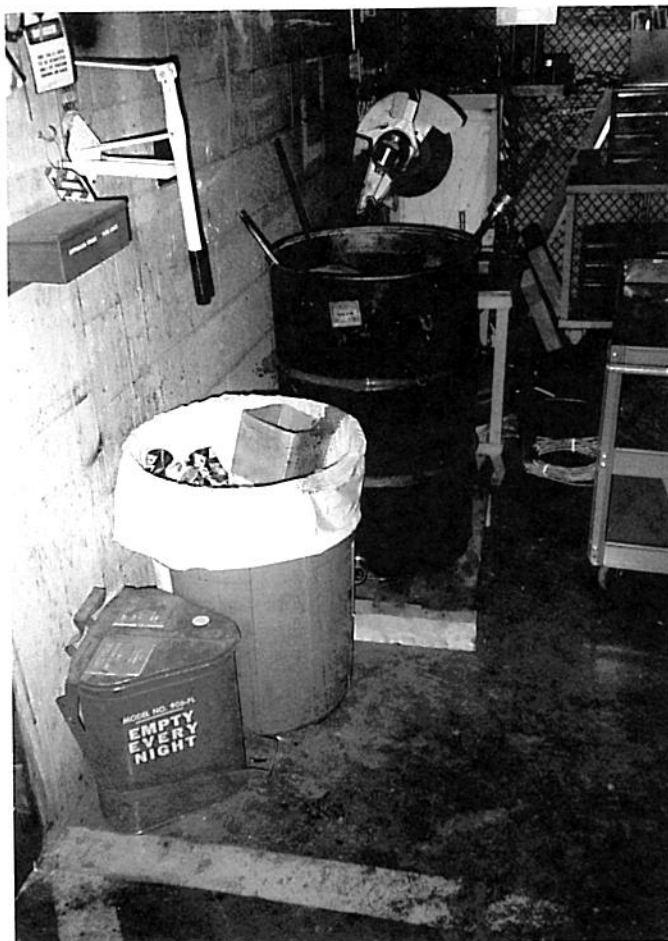
18 01-06-92, 10:05 a.m. General Products Maintenance Department. Scrap Metal Drum Storage Container (SWMU #12). Photo taken by Michael Lanz.

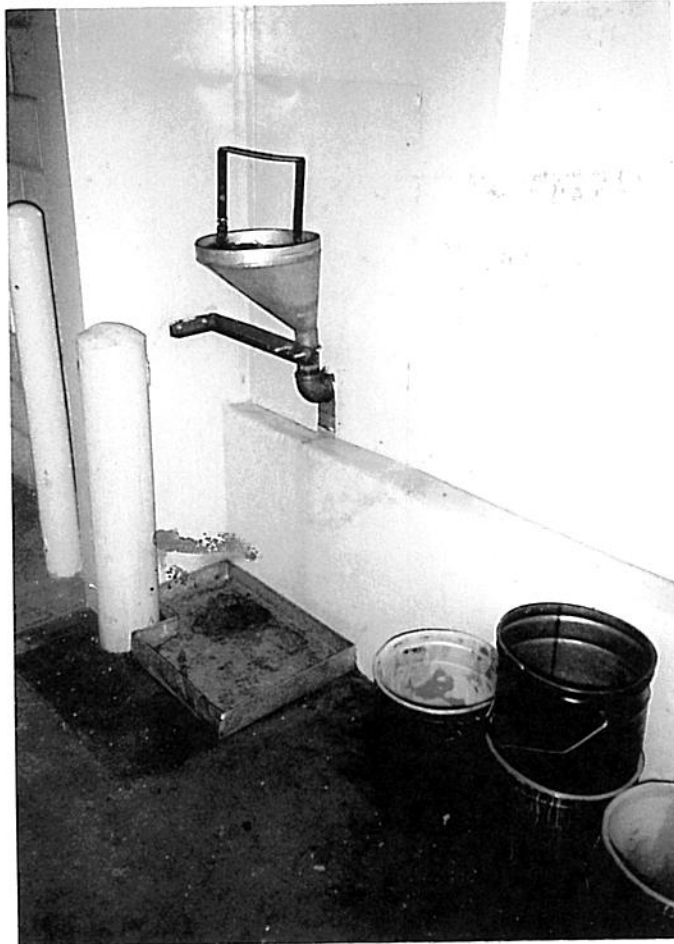
- 19 01-06-92, 10:32 a.m. Between Stretch and General Products Manufacturing Departments, east side of plant. Aluminum Funnel Drain component of Waste Oil Management System (SWMU #13). Photo taken by Michael Lanz.

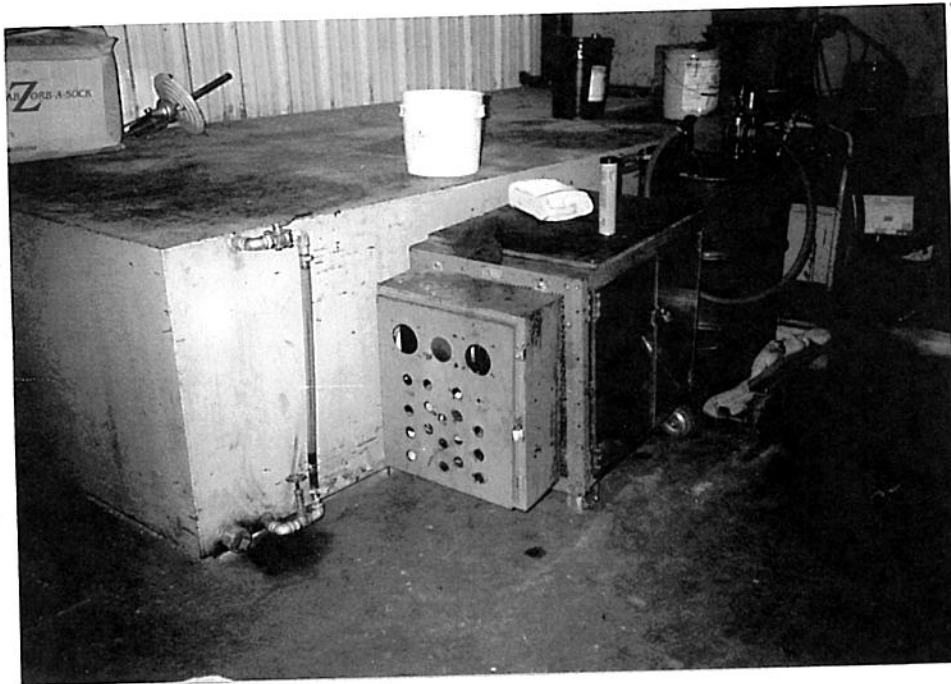
- 20 01-06-92, 10:34 a.m. Between Stretch and General Products Manufacturing Departments, east side of plant. 2,700-Gallon Above-Ground Waste Oil Tank component of Waste Oil Management System (SWMU #13) Photo taken by Michael Lanz.

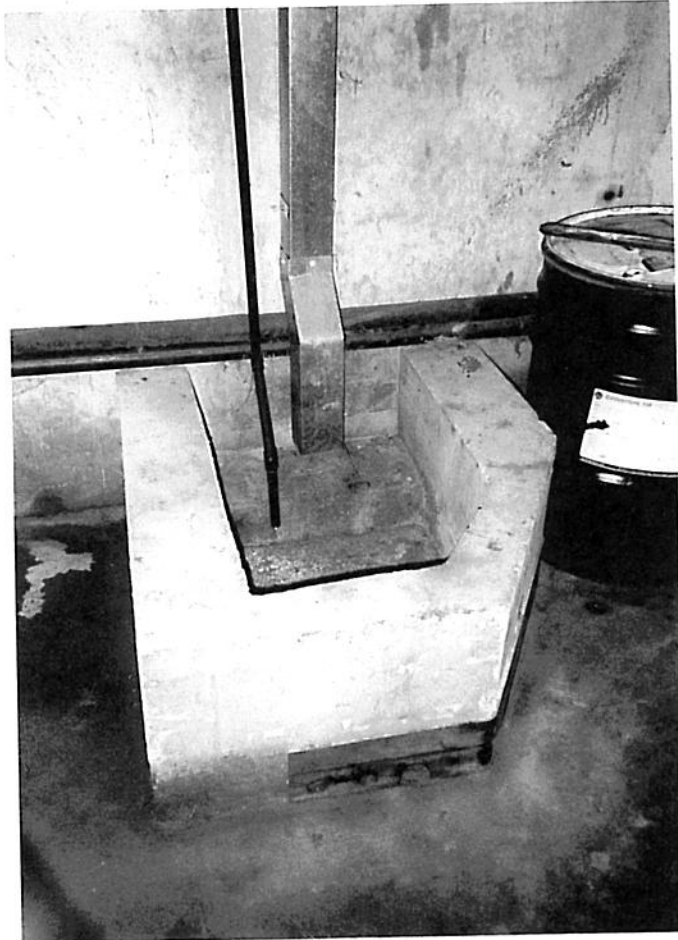
- 21 01-06-92, 10:35 a.m. Between Stretch and General Products Manufacturing Departments, east side of plant. Sewer Drain located in 2,700-gallon waste oil tank room (SWMU #13). Photo taken by Michael Lanz.

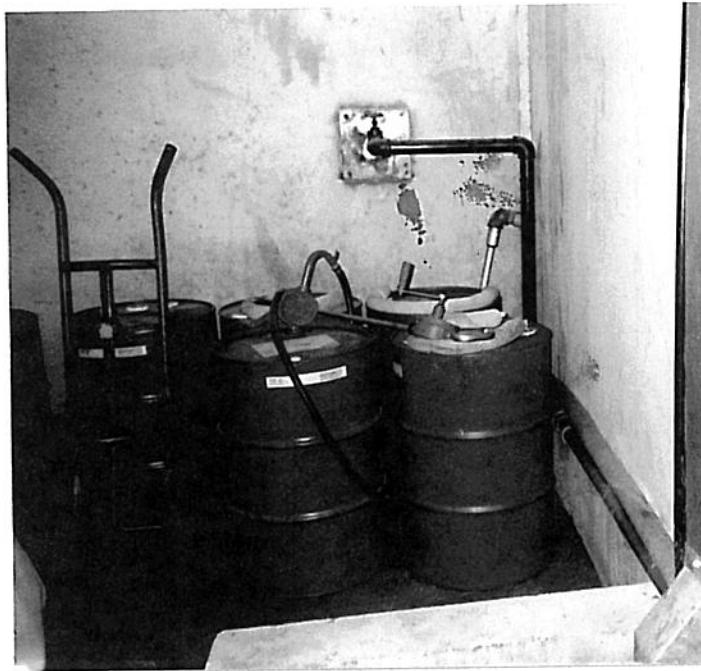
- 22 01-06-92, 10:40 a.m. Between Stretch and General Products Manufacturing Departments, east side of plant. Pipe component of Waste Oil Management System (SWMU #13), leading to the Truck Hook-Up (outside building). Photo taken by Michael Lanz.

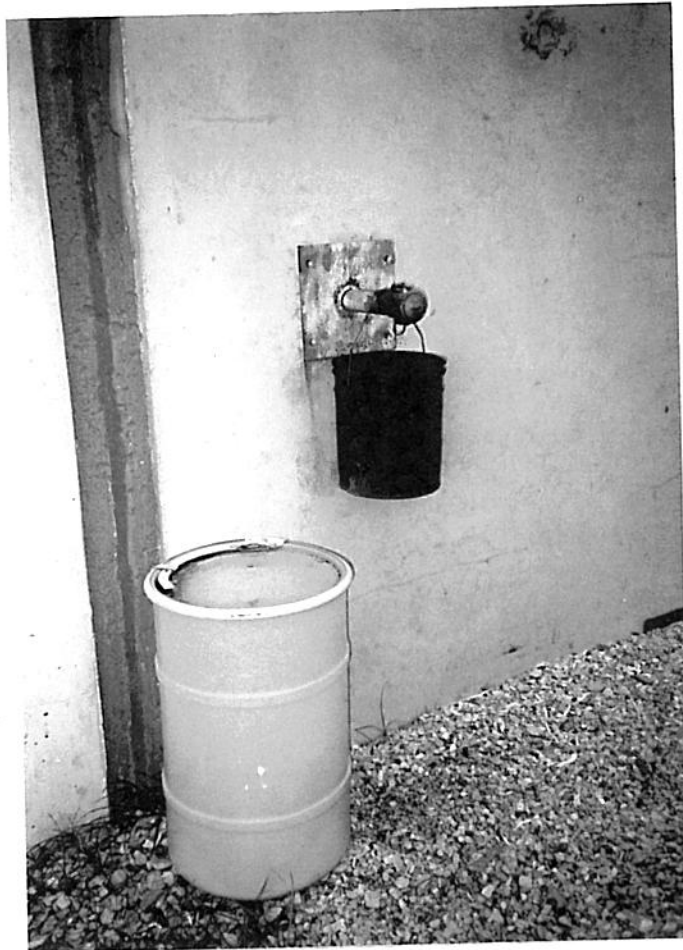
- 23 01-06-92, 10:45 a.m. View facing west. East side of Stretch and General Manufacturing Departments. Truck Hook-Up component of the Waste Oil Management System (SWMU #13). Photo taken by Michael Lanz.

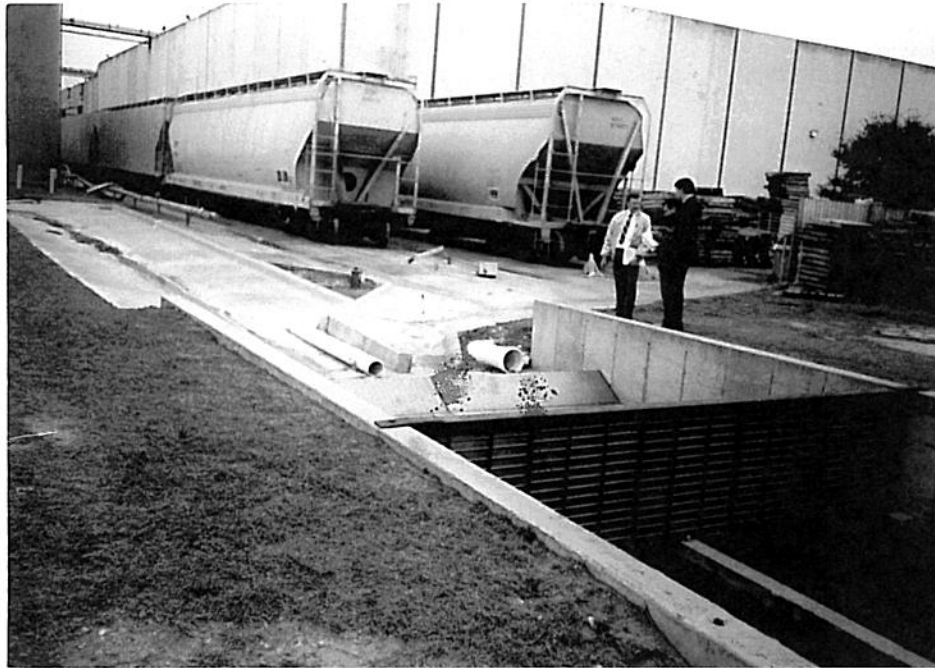
24 01-06-92, 10:50 a.m. View to the north, with Stretch plant in background. Pellet Retention Screen-Southwest Outfall. (SWMU #14) Photo taken by Michael Lanz..

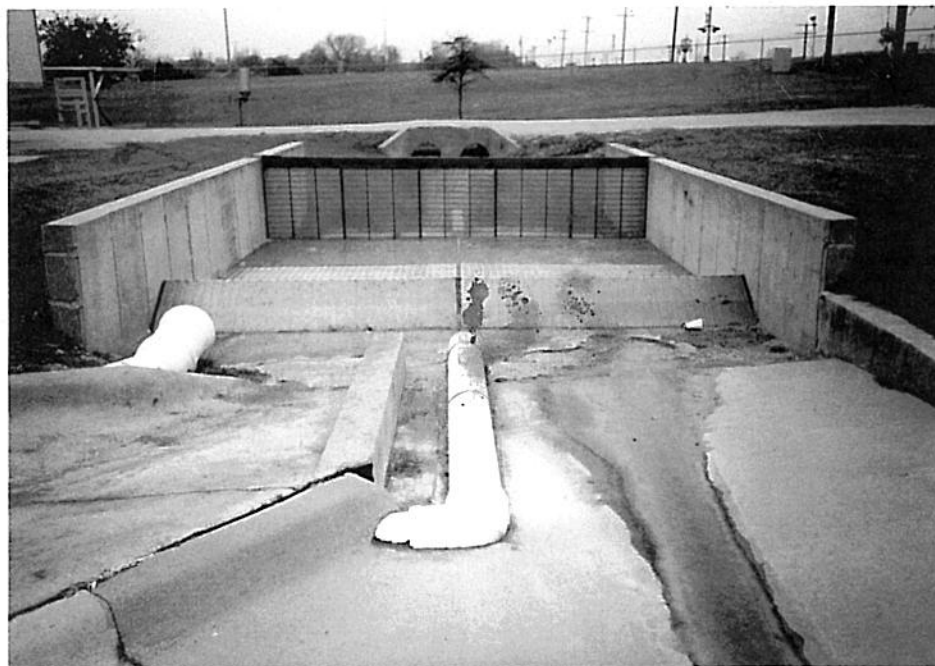
25 01-06-92, 10:52 a.m. View to the south. Pellet Retention Screen-Southwest Outfall (SWMU #14). Photo taken by Michael Lanz.

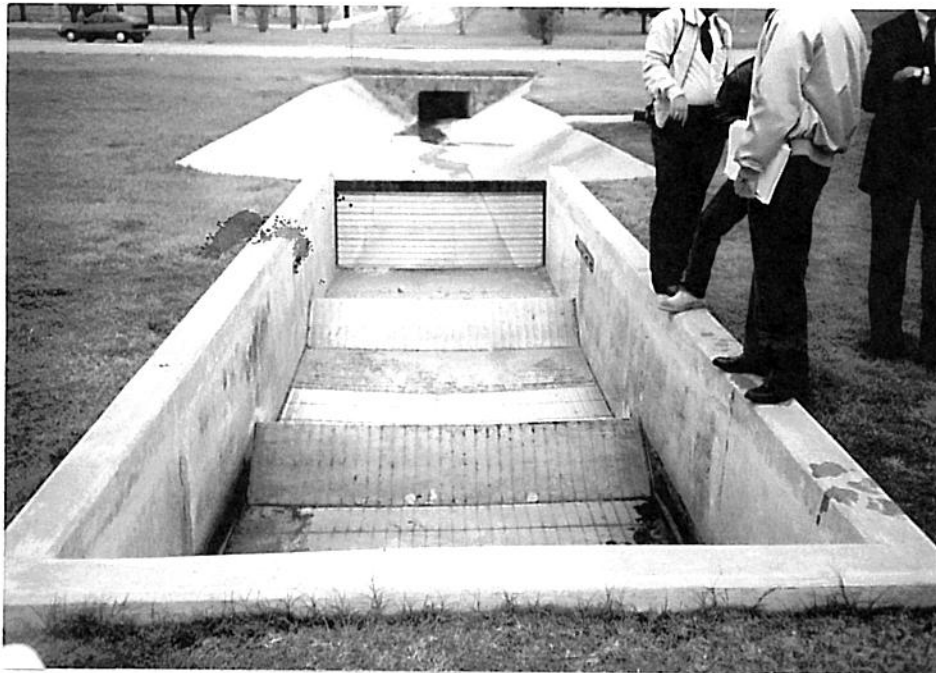
26 01-06-92, 10:53 a.m. View to the west. Pellet Retention Screen-Southeast Outfall (SWMU #14). Photo taken by Michael Lanz.

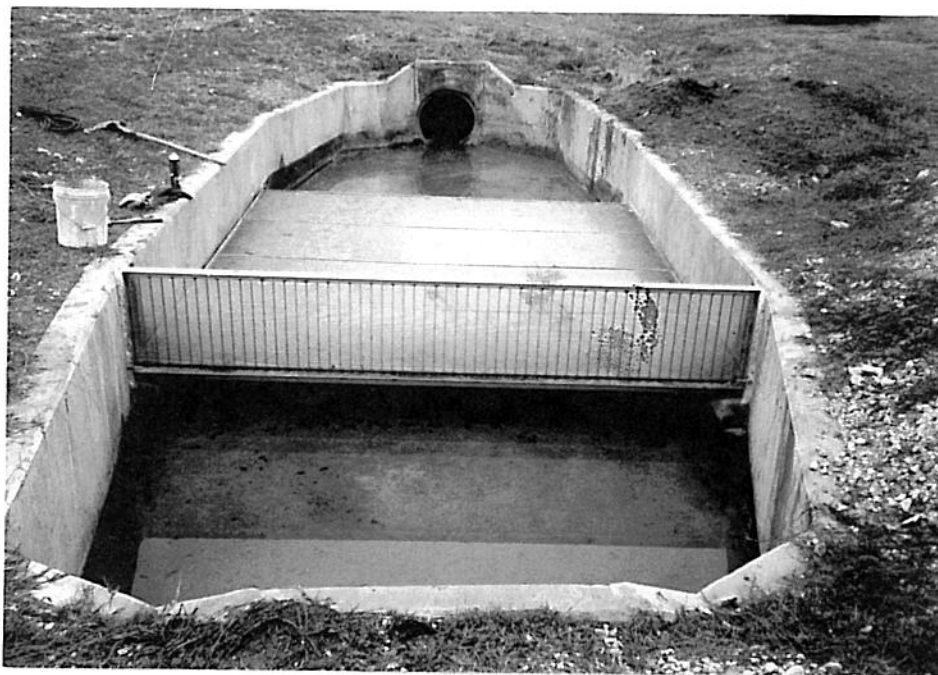
27 01-06-92, 10:54 a.m. View to the north. Pellet Retention Screen-West Outfall (SWMU #14). Photo taken by Michael Lanz.

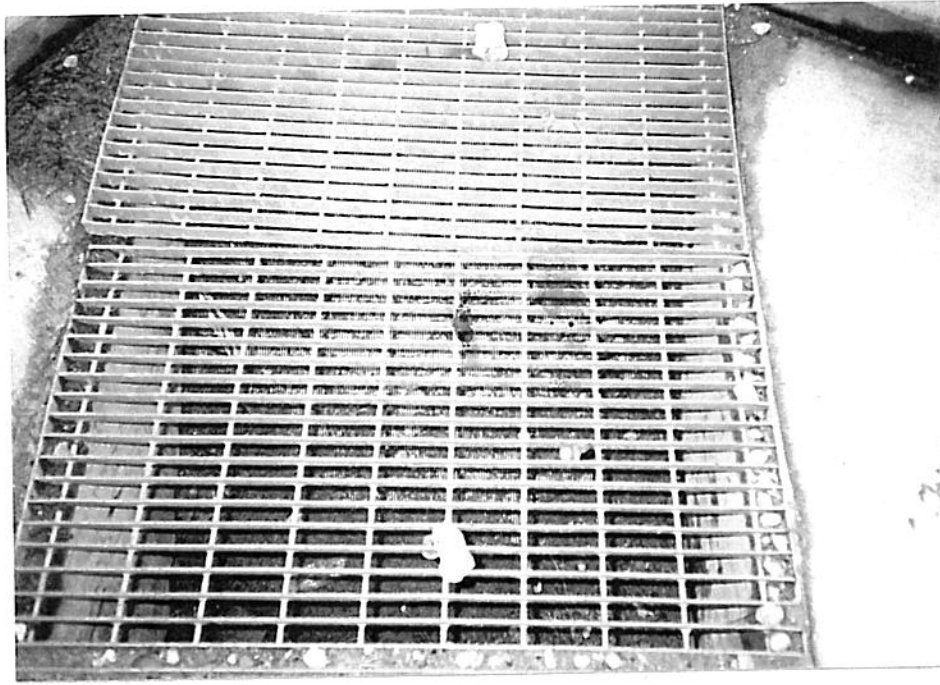
28 01-06-92, 10:58 a.m. View facing northwest. Pellet Retention Screen-Polystyrene Unload Area (SWMU #14). Photo taken by Michael Lanz.

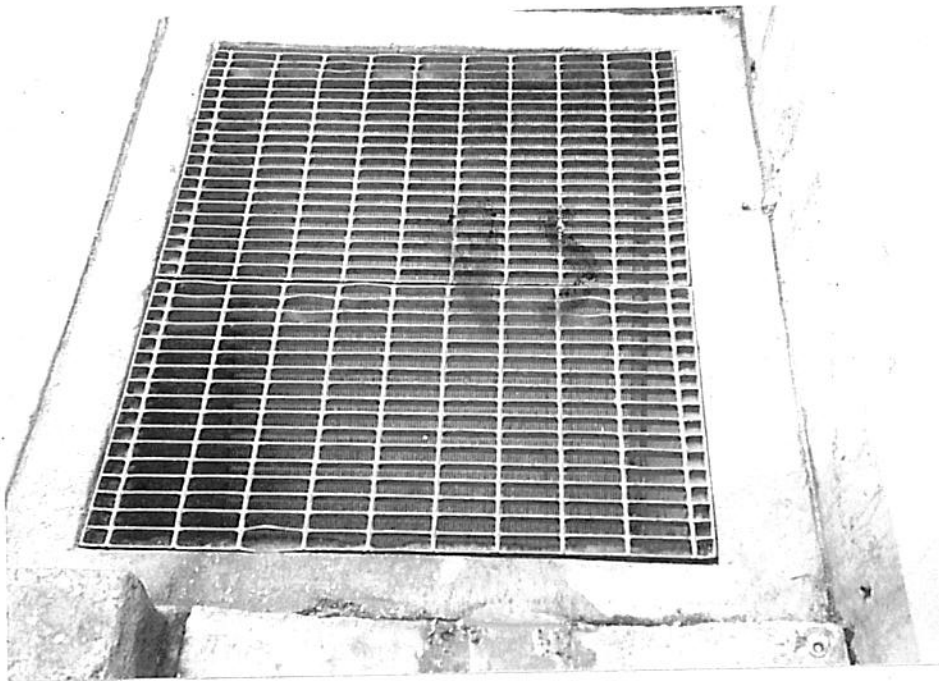
29 01-06-92, 10:59 a.m. View facing west. Pellet Retention Screen-West End of Polystyrene Silo Area (SWMU #14). Photo taken by Michael Lanz.

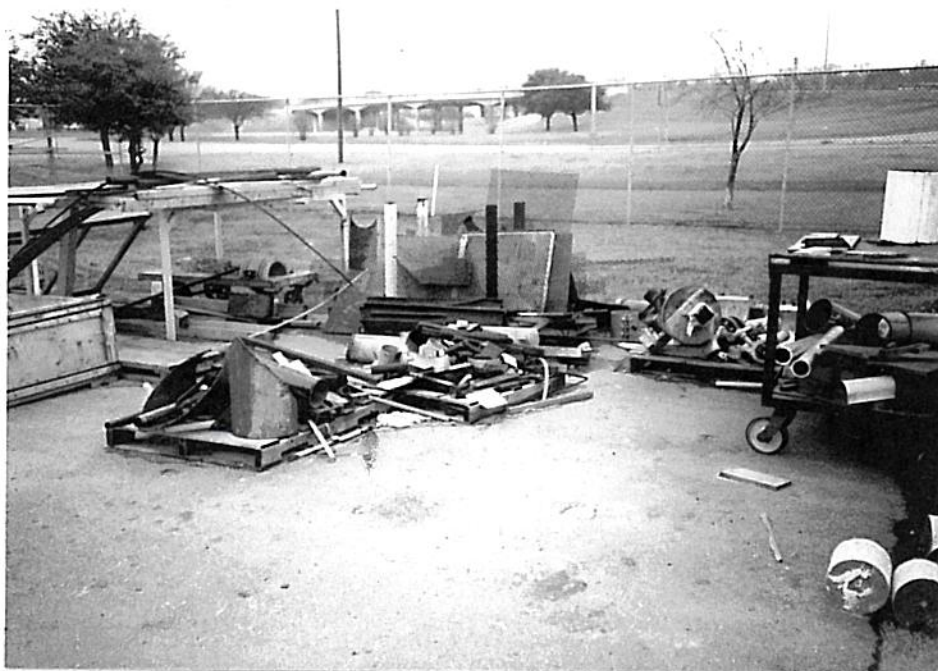
30 01-06-92, 11:30 a.m. View facing southeast. Scrap Metal Storage Area (SWMU #15).
Photo taken by Michael Lanz.

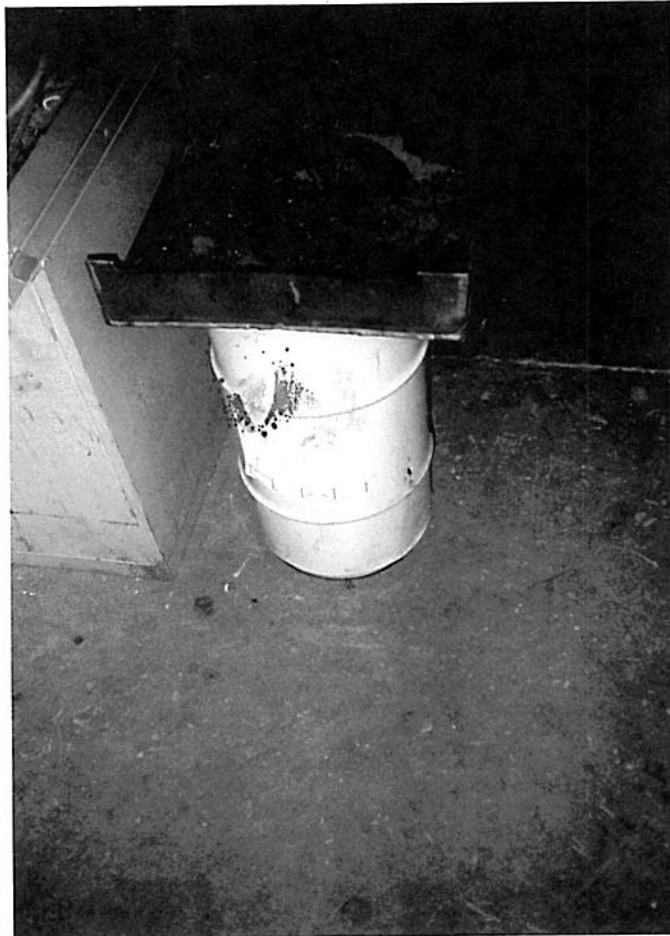
- 31 01-06-92, 12:15 p.m. Maintenance area of Foams plant. Temporary Used Oil Accumulation Area (SWMU #18). Photo taken by Michael Lanz.

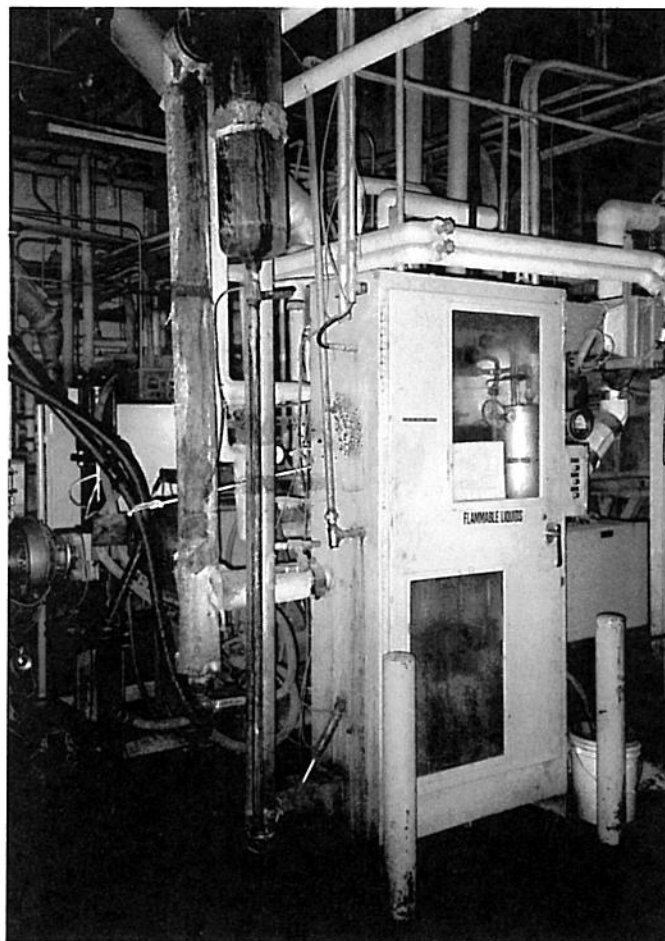
- 32 01-06-92, 12:30 p.m. Foam plant Pentane Reclaim Department. Pentane Condenser Unit (SWMU #19). Photo taken by Michael Lanz.

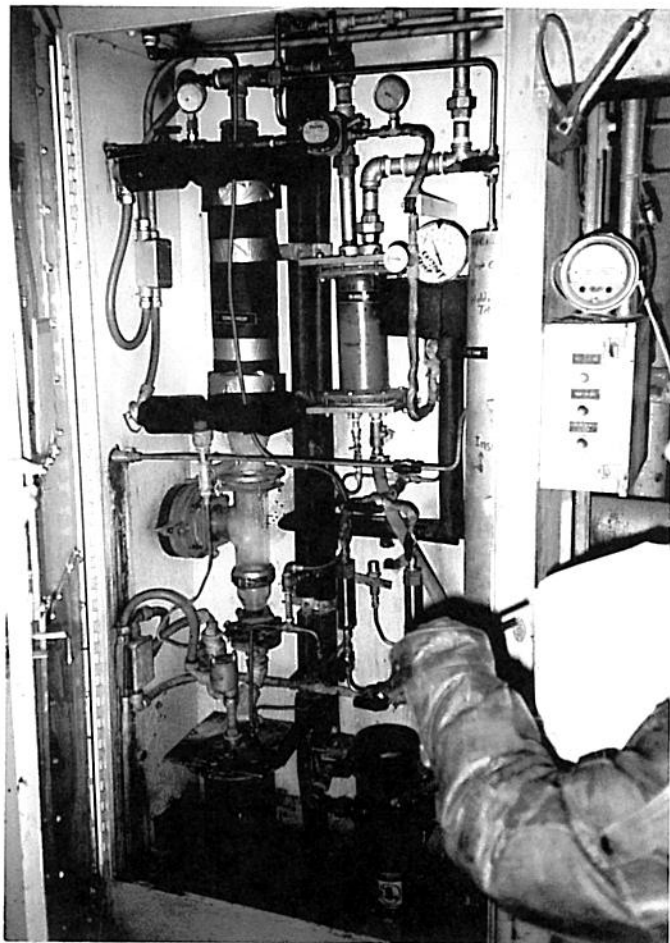
33 01-06-92, 12:32 p.m. Foam plant Pentane Reclaim Department. Inside of Pentane Condenser Unit (SWMU #19). Photo taken by Michael Lanz.

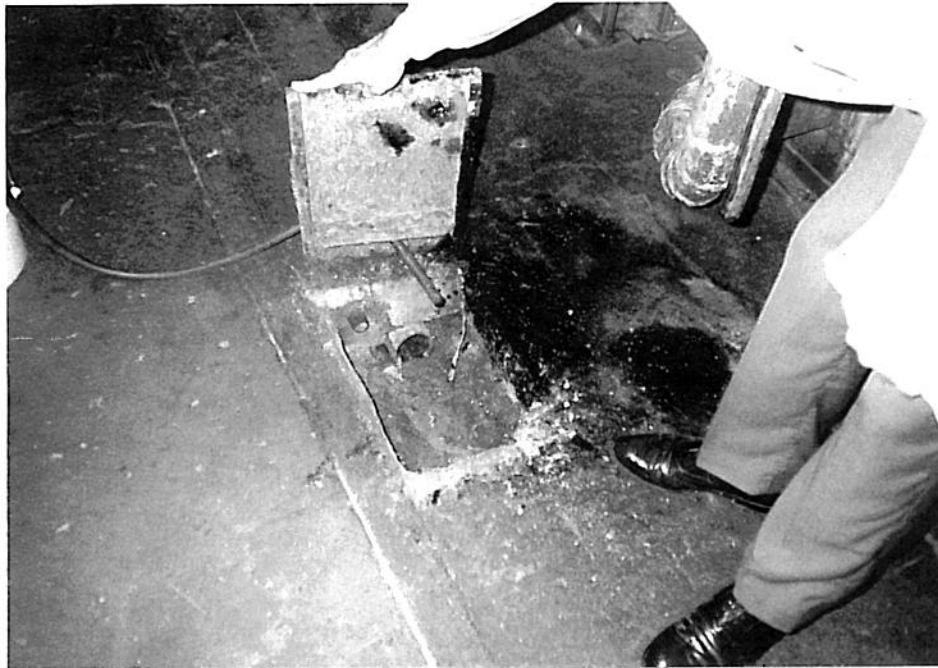
- 34 01-06-92, 12:32 p.m. Area under Knock-Out Pot (SWMU #19). Note leaked oil on floor and in drain from Knock-Out Pot with faulty valve. Photo taken by Michael Lanz.
